**Archaeological Testing and Monitoring Plan for  
Room 6 Floor Joist Assessment and Rehabilitation,  
Palace of the Governors (LA 4451), Santa Fe, New Mexico**

Administrative Report 157

Revision 3

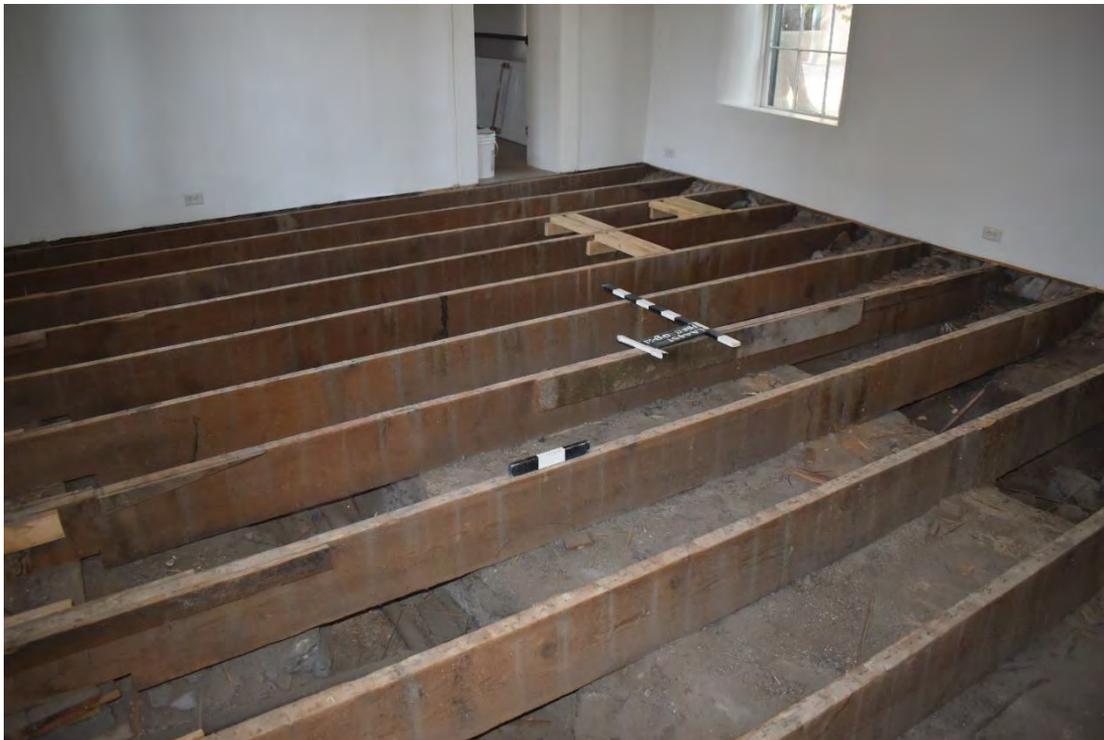
Figure 27. Overview of Room 6 from the southwest room corner. Note the blocking reinforcements near the door to Room 19.

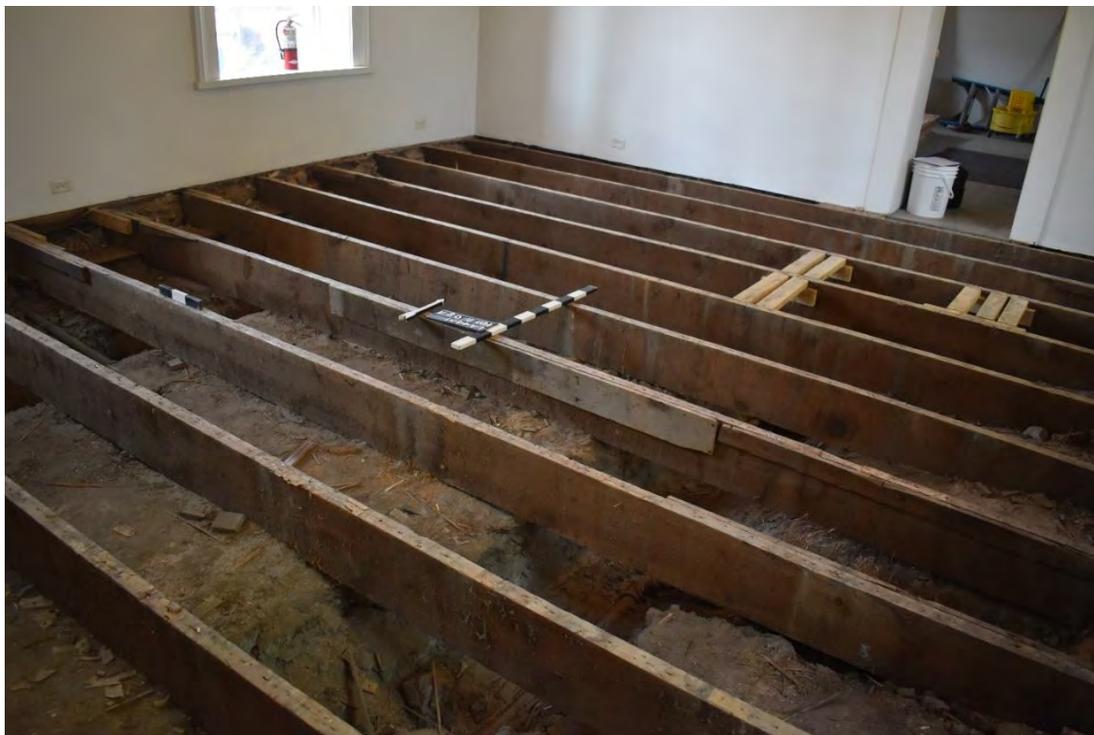
Figure 28. Overview of Room 6 from the southeast room corner. Note the “sister” added to the face of the joist under the metric scale.

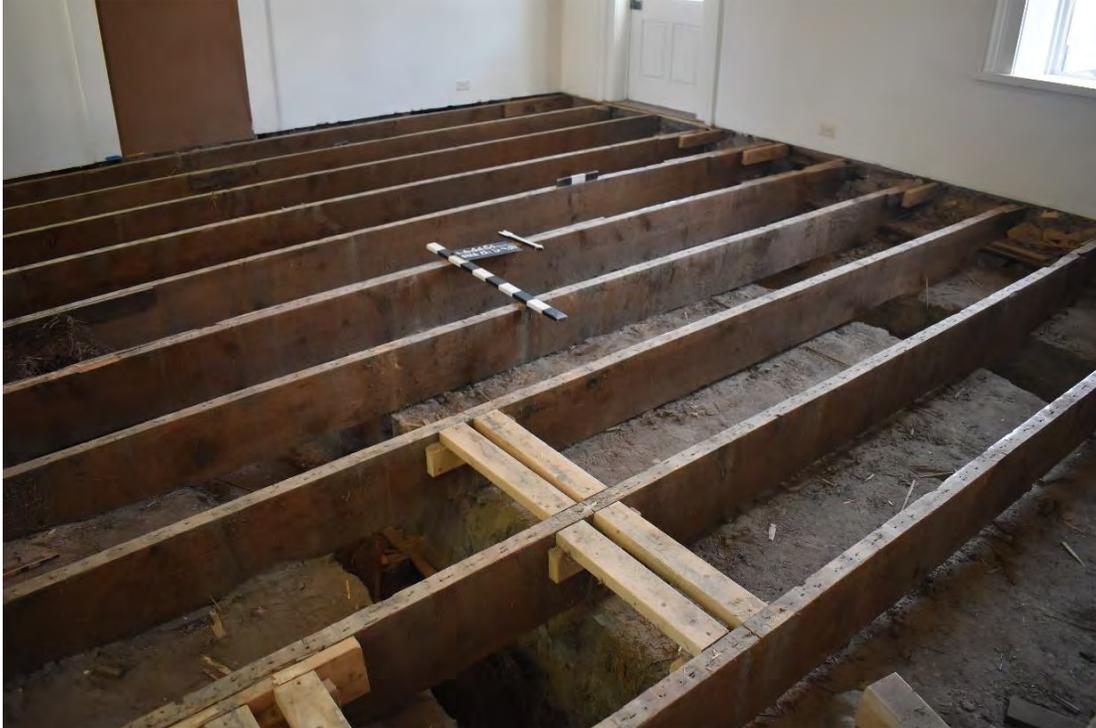
Figure 28. Overview of Room 6 from the northeast room corner. Note that the joist ends are supported by a constructed shelf adjacent to the Lincoln Avenue wall foundation.

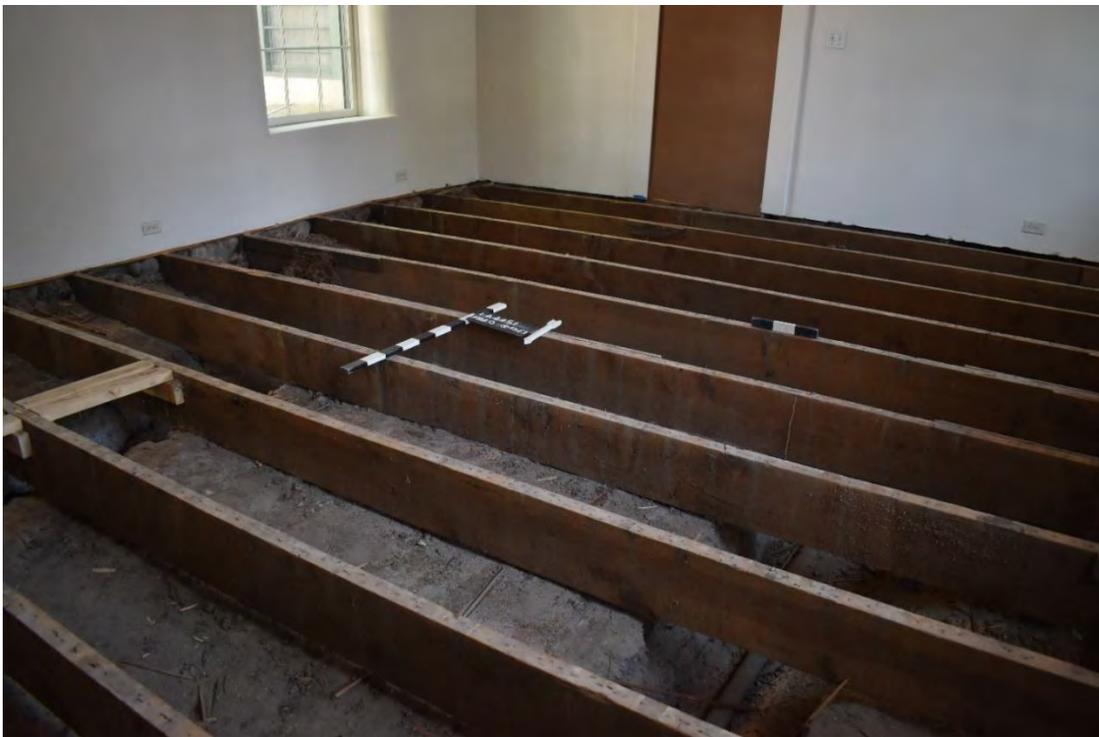
Figure 29. Overview of Room 6 from the northwest room corner. Note that joist ends are seated within the east (courtyard) wall foundation.

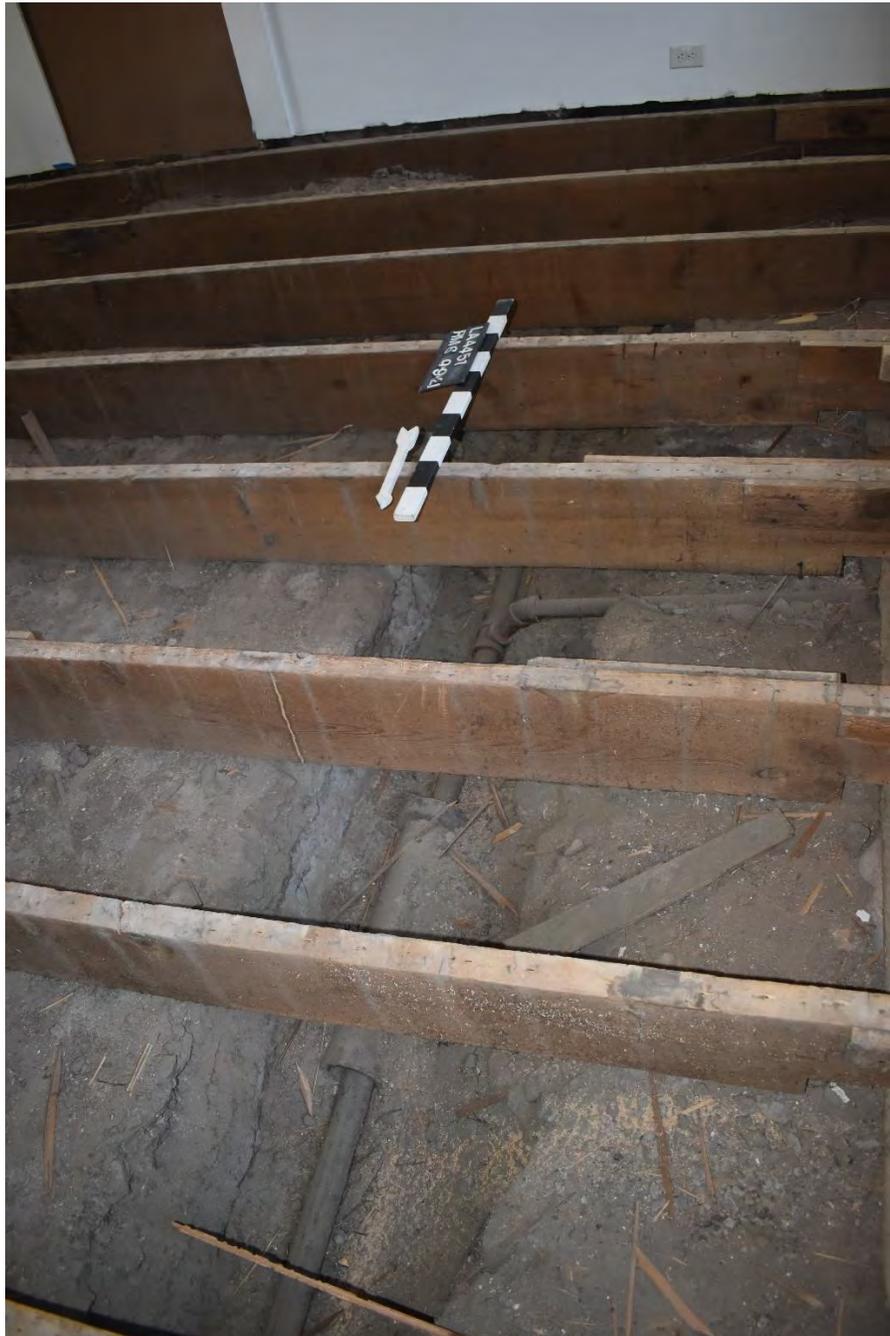
Two north-south trenches run the length of Room 6 beneath the joists and are unbackfilled (Figure 30). The trenches contain iron pipe that appears to have been installed as part of an acetylene gas lighting system, with branches that carry the gas to positions at the bases of the east and west walls of the room. The vertical pipe segments were removed from the branches at some point, and the existence of the trenches and the gas lines has not been previously documented. The pipes and trenches do not penetrate into Room 5 (they were not encountered during the archaeological investigations of Room 5), and their installation was probably very late in 1880, predating the construction of Room 19 to the north.

Figure 30. Detail of the eastern the sub-joist trench and its gas line. Note the larger diameter pipe sleeve in the main trench.

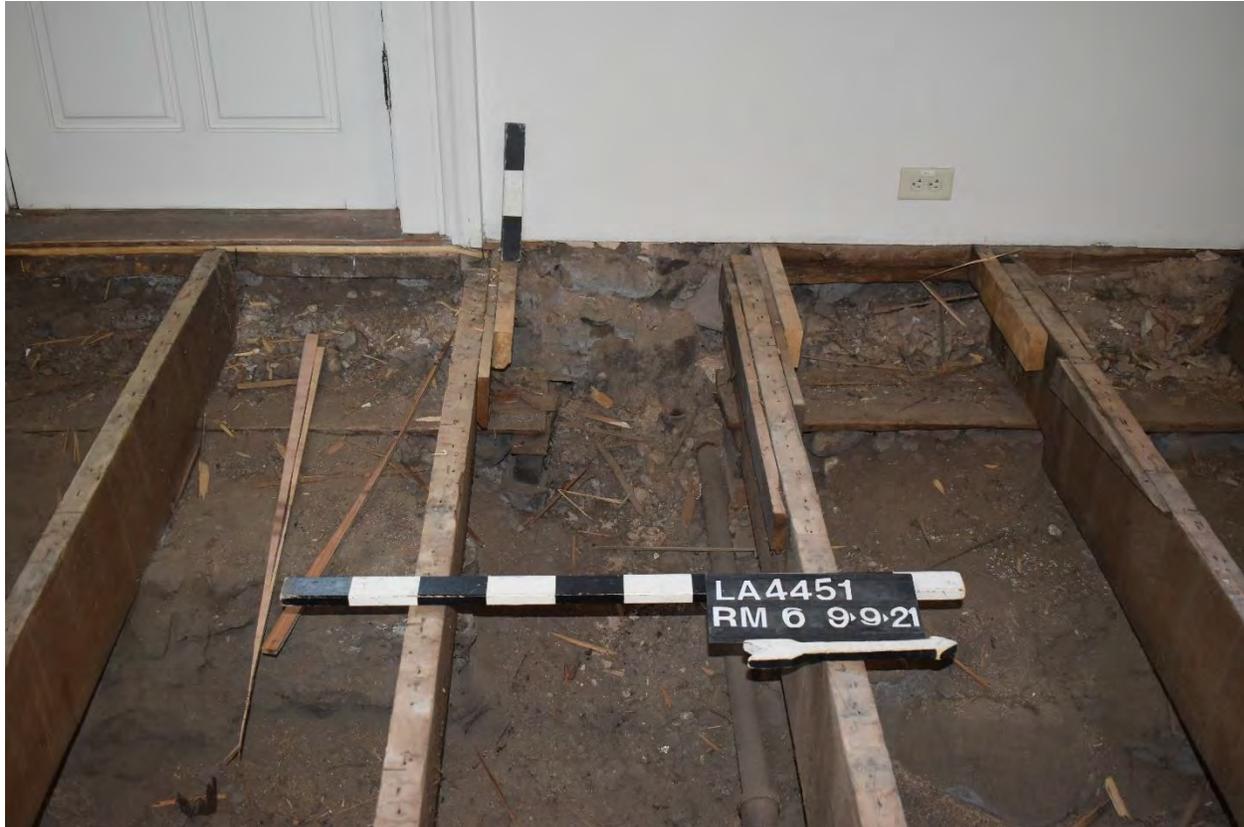
Figure 31 depicts the typical conditions along the west (Lincoln Avenue) wall of Room 6. The ends of the joists are notched to rest on a wood shelf that is set out from the base of the wall. The shelf is supported by rock footings adjacent to the footings for the wall, but the relationship (bonding or abutting) between the wall footings and the shelf footings is uncertain. The joist ends are often reinforced by one and in many cases two generations of “sisters,” some of which appear to have been set deeper into the wall foundation than the original joist. Where a secondary gas line has been installed to rise up the face of the wall, the shelf appears to have been cut to accommodate the line. Also visible in Figure 31 is a massive cobble (below the tip of the north arrow), exposed in the side of the gas line trench. This type and scale of cobble is commonly associated with pre-Fort Marcy wall foundations.

Figure 31. Typical joist-wall junction along the west (Lincoln Avenue) wall of Room 6.

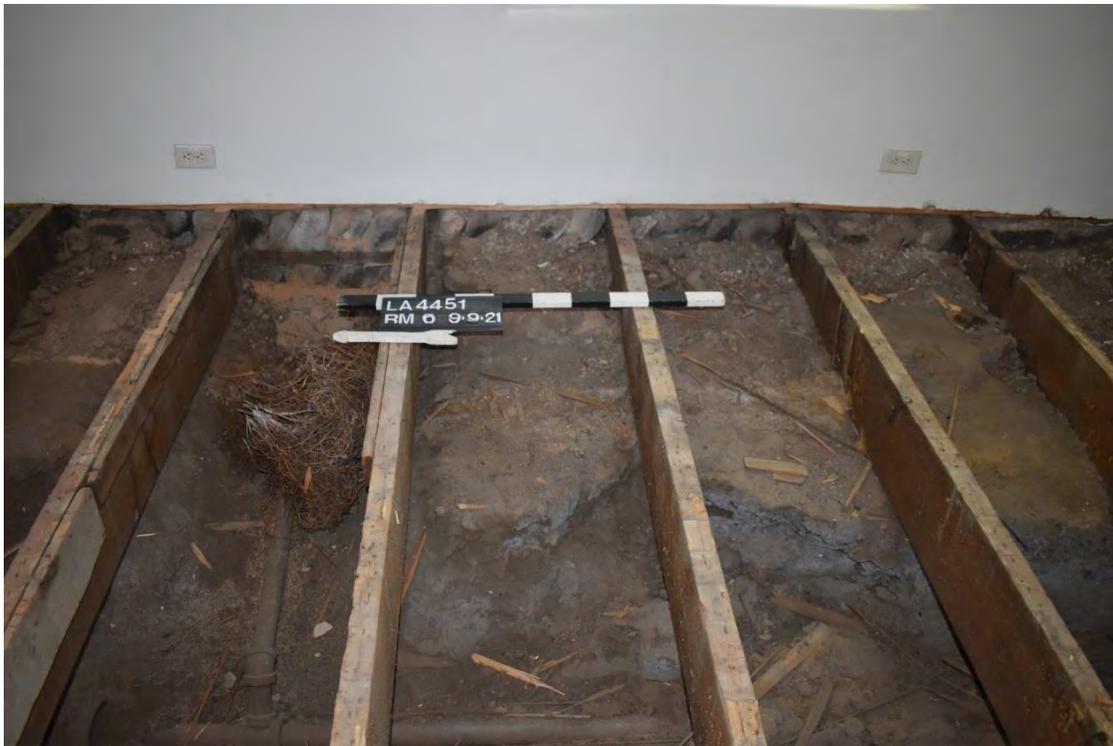
Typical conditions along the east (courtyard) wall of Room 6 are depicted in Figure 32. The ends of the joists are also notched, resting on a wooden shelf. However, the shelf is fully under the wall and the upper ends of the joists are integrated into the upper portion of the wall footings. Imbricated small cobbles provide bracing support between adjacent joist ends. There is substantially more inter-joist debris along the east wall of Room 6, dominated in this case by sediment that probably is derived from degradation of the mortar and adobe bricks of the wall above. Since the support for the joist ends is within the wall above, there appears to have been no need to modify the joist support system for the installation of the gas line.

Figure 32. Typical joist-wall junction along the east (courtyard) wall of Room 6. Note the greater depth of sediment that has accumulated against the joist surfaces and that will need to be removed.

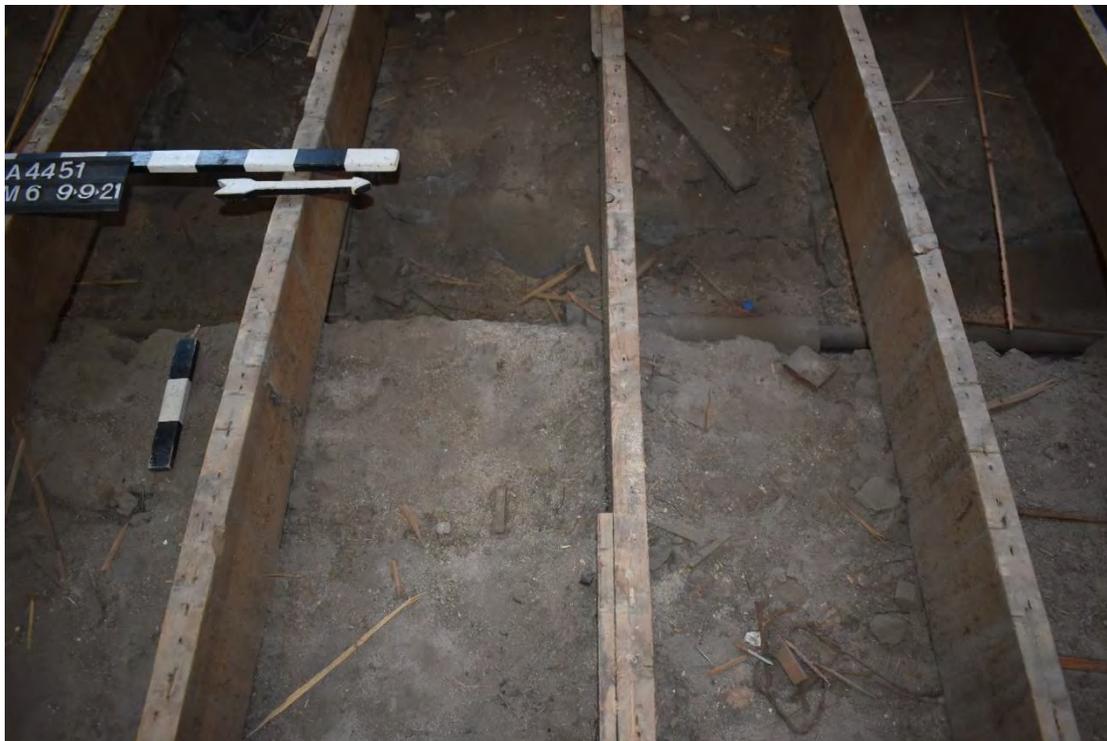
Another feature worthy investigation is an area of the sub-joist surface between the gas line trenches that shows a linear crack (Figure 33). The crack is linear and of sufficient length that it appears to represent a vertical plane of weakness in the subfloor earth. This may be indicative of the upper boundary of a feature, perhaps the edge of an adobe wall or a boundary of or within an adobe floor.

Figure 33. Section of inter-trench surface with a possible floor feature. The line of weakness is at the base of the 30 cm scale and extends at least from the left-most joist to the middle of the third inter-joist space.

3) Careful cleaning of the sub-joist surface in the vicinity of the apparent crack or area of weakness may reveal whether there is evidence that an adobe wall or portions of an earlier adobe brick floors were razed

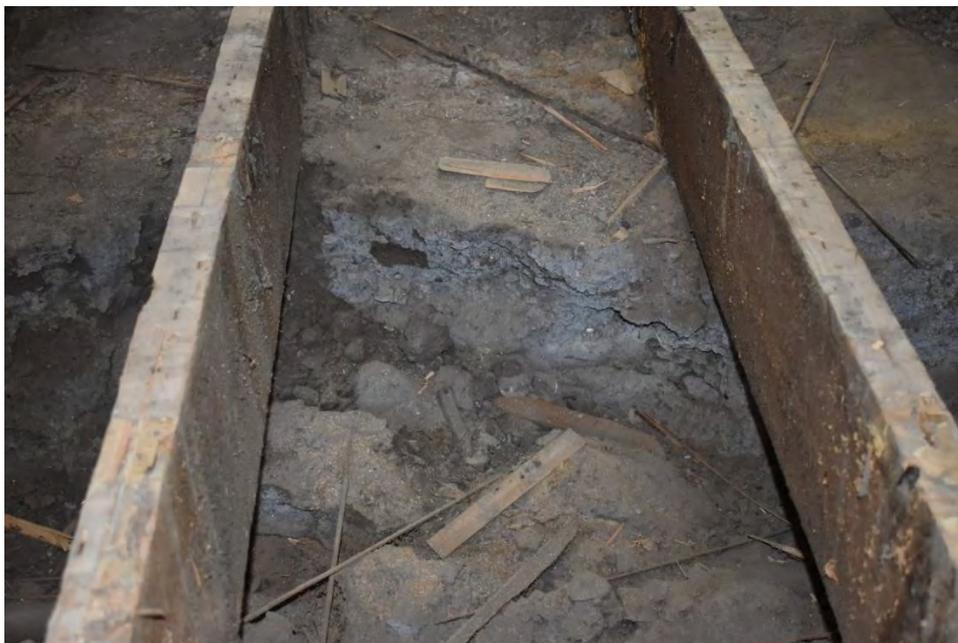
Figure 35. Slumped sediments from a trench sidewall in the bottom of the trench.

Slump blocks of trench wall sediments are present in some areas of the gas line trenches, presumably due to past mis-steps during floor installation or replacement. In comparison with the adjacent stratigraphic profiles, portions of some slump blocks may have significant historic information potential. If consultation with NMHM and NM-HPD determines that sampling of the slump blocks will not destabilize intact adjacent archaeological deposits, the already slumped materials will be sampled or collected in total and will be subjected to laboratory analyses (e.g., flotation analysis).

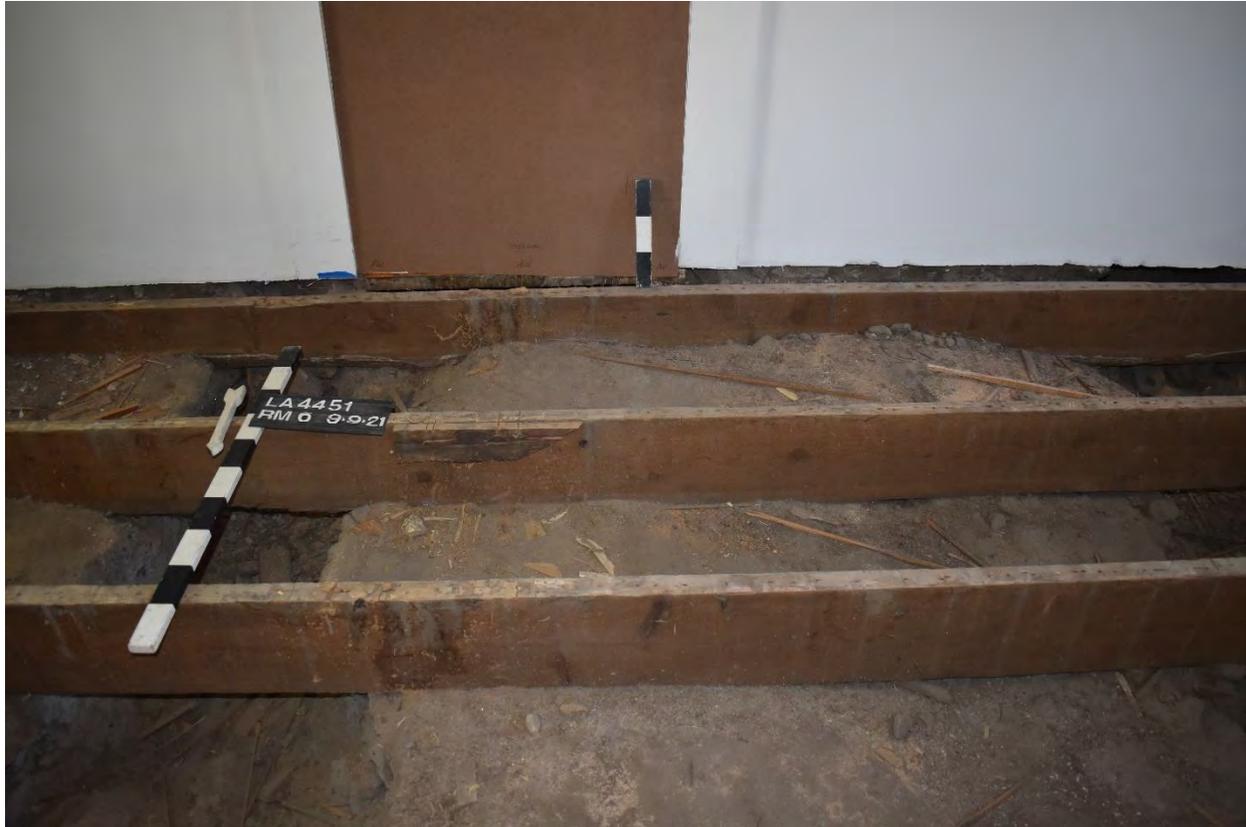
Although most attention will be directed toward the west and east walls, severe joist condition issues are present along the south wall (Figure 36). Debris (earth) rests directly against the southernmost joist in the center of its span as well as at its east and west ends. The thickness of this deposit is relatively great, and there is evidence of water damage and visible rot toward the east end of the joist.

Figure 36. The southern three joists within Room 6. The southernmost joist may require complete replacement due to condition issues.
